Evaluation of Bacterial Concrete Corrosion Resistance in Marine Settings: A Morphological Analysis Perspective

Abstract

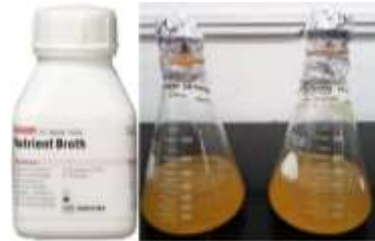
Figure-1 Making of bacterial solution

Bacillus subtilis bacteria should be cultured before being mixed into the concrete. To prepare the culture, add 1.5 grams of beef extract, 2.5 grams of peptone, and 2.5 grams of NaCl to 500ml of distilled water in a conical flask. Seal the mouth of the conical flask with cotton and cover it with silver foil. An autoclave is used to sterilize the nutrient broth solution for 20 minutes at 121°C with 15 lbs pressure. Water is filled in the autoclave up to level 1. This process removes contaminants from the solution, resulting in an orange-coloured solution. Subsequently, the flask is opened and exposed to laminar airflow, and a pinch of bacteria is added to the solution [10]. The flask is then placed in an orbital shaker and maintained at 125 rpm at a temperature of 37°C. As the bacteria grow, the color of the solution changes to turbid yellow, indicating the growth of Bacillus subtilis (Figure-1).

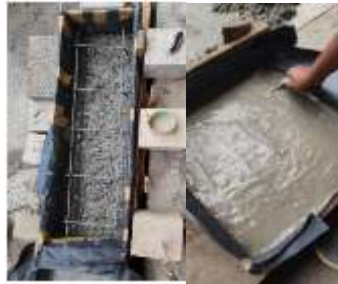
Figure-2 Specimen preparation

This section describes the methodology used to achieve the objectives of the work. Details of the methods adopted in preparing the test specimens and the different test procedures are discussed. The methods employed in preparing the test specimens, including casting and curing, are also described. Size of beam mould is 100cm X 20cm X 25cm and of slab mould is 50cm X 40cm X

15cm. There are four beams made of normal concrete and four made of bacterial concrete, along with three slabs of each type (Figure -2). The casted beams and slabs are removed from the mould within 24 hours. Specimens are kept in sea water for 28 days, 90 days, 120 days and 365 days

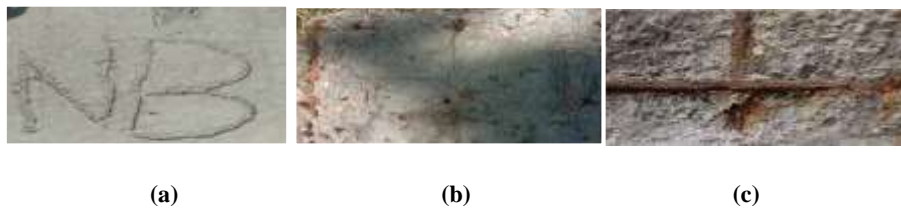
Figure-5 Bacterial concrete slab before and after 365 days of immersion in sea water

Additionally, Figures 5 and 6 show normal and bacterial concrete slabs before and after immersion in seawater, as well as the corrosion rate in both. Here also bacterial concrete slab shows very less corrosion.
